Interior Panels Sticky/Poor Appearance

Service Category Vehicle Interior

Section Interior Panels/Trim

YEAR(S)	MODEL(S)	ADDITIONAL INFORMATION
2006 – 2008	IS250, IS350

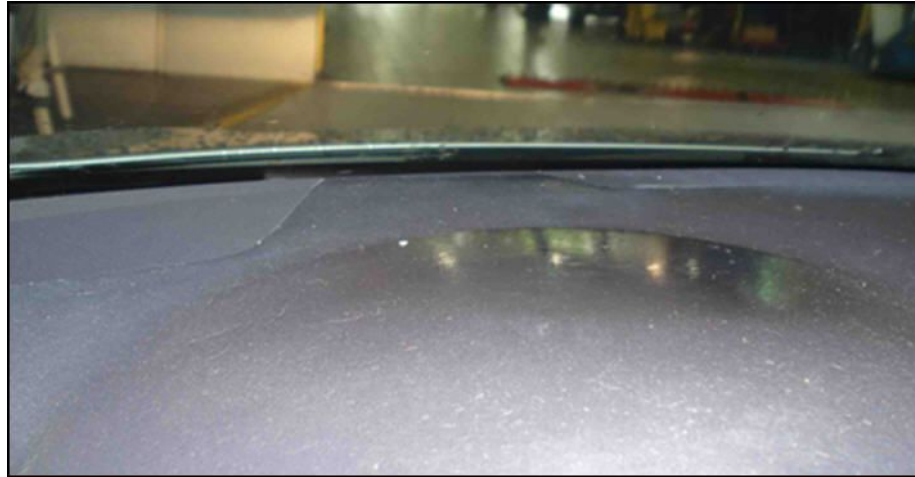
Figure 1.

Some 2006 – 2008 model year IS 250/350 vehicles may exhibit sticky interior panels that have a shiny/degraded appearance. This condition may be present on the Instrument Panel Pad and/or the Door Panel Trim. Revised interior panels have been developed to address this condition.

1. Confirm the customer specified interior components for sticky feel/poor appearance (see Figure 1).
 - If sticky components are identified, continue to step 2.
 - If not, this TSIB does NOT apply.

2. Remove the affected interior panel.

3. Install the NEW interior components.
