GROUP	MODEL
Voluntary Emissions Service Campaign	2021-2024MY K5 (DL3a) w/1.6L T-GDI
NUMBER	DATE
SC288	April 2024

FUEL TANK AND/OR PCSV CHECK VALVE INSPECTION/REPLACEMENT + ECU SW UPGRADE (SC288)

This bulletin provides information to inspect the fuel evaporative system and, if necessary, replace the fuel tank and/or the Purge Control Solenoid Valve (PCSV) check valve on certain 2021-2024MY K5 (DL3a) vehicles equipped with a Gamma II 1.6L T-GDI engine, produced from March 27, 2020 through October 17, 2023. This bulletin also provides information to upgrade the ECU software logic. The subject vehicles may experience fuel tank swelling due to an issue with the PCSV check valve, which results in pressurized air to flow into the fuel tank. This may cause the Check Engine Light to illuminate, and in some cases, the engine to run rough, and/or an inability to refuel. These conditions may cause the vehicle to release air pollutant which exceed Federal and California standards.

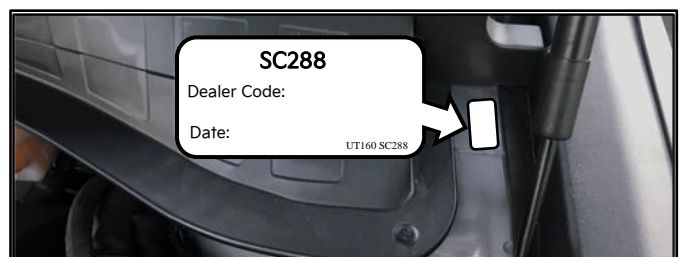
CA and S.177 States Only: Apply SC288 Campaign Completion Label onto the body in the area next to the shock tower, as shown. **NOTE: Be sure to clean the mounting surface to ensure proper label adhesion.**

The dealer must fill in the Dealer Code and Date information fields on the Campaign Completion Label. Once complete, affix the campaign completion label under the hood of the vehicle, as shown below.
